**INFILTRATION ANALYSIS & NOLIN SOILS INVESTIGATION**

**Rahal Honda  
Ferguson Township, Centre County, Pennsylvania**

**CMT Laboratories File No. 2114800**

**July 8, 2021**

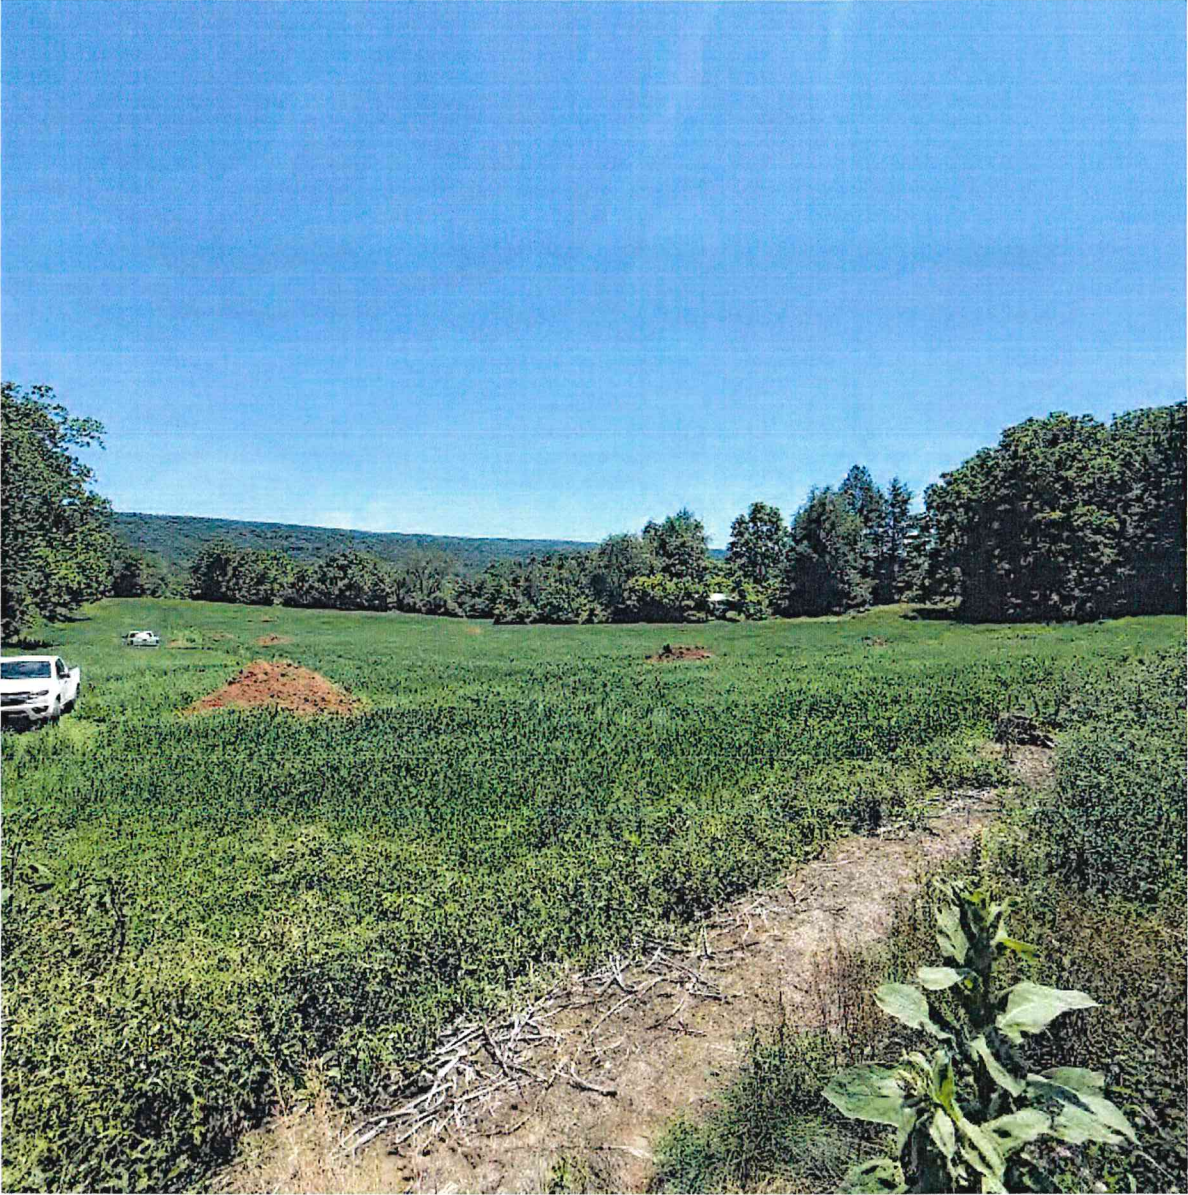
Photograph 1: Looking SW across Areas B and A

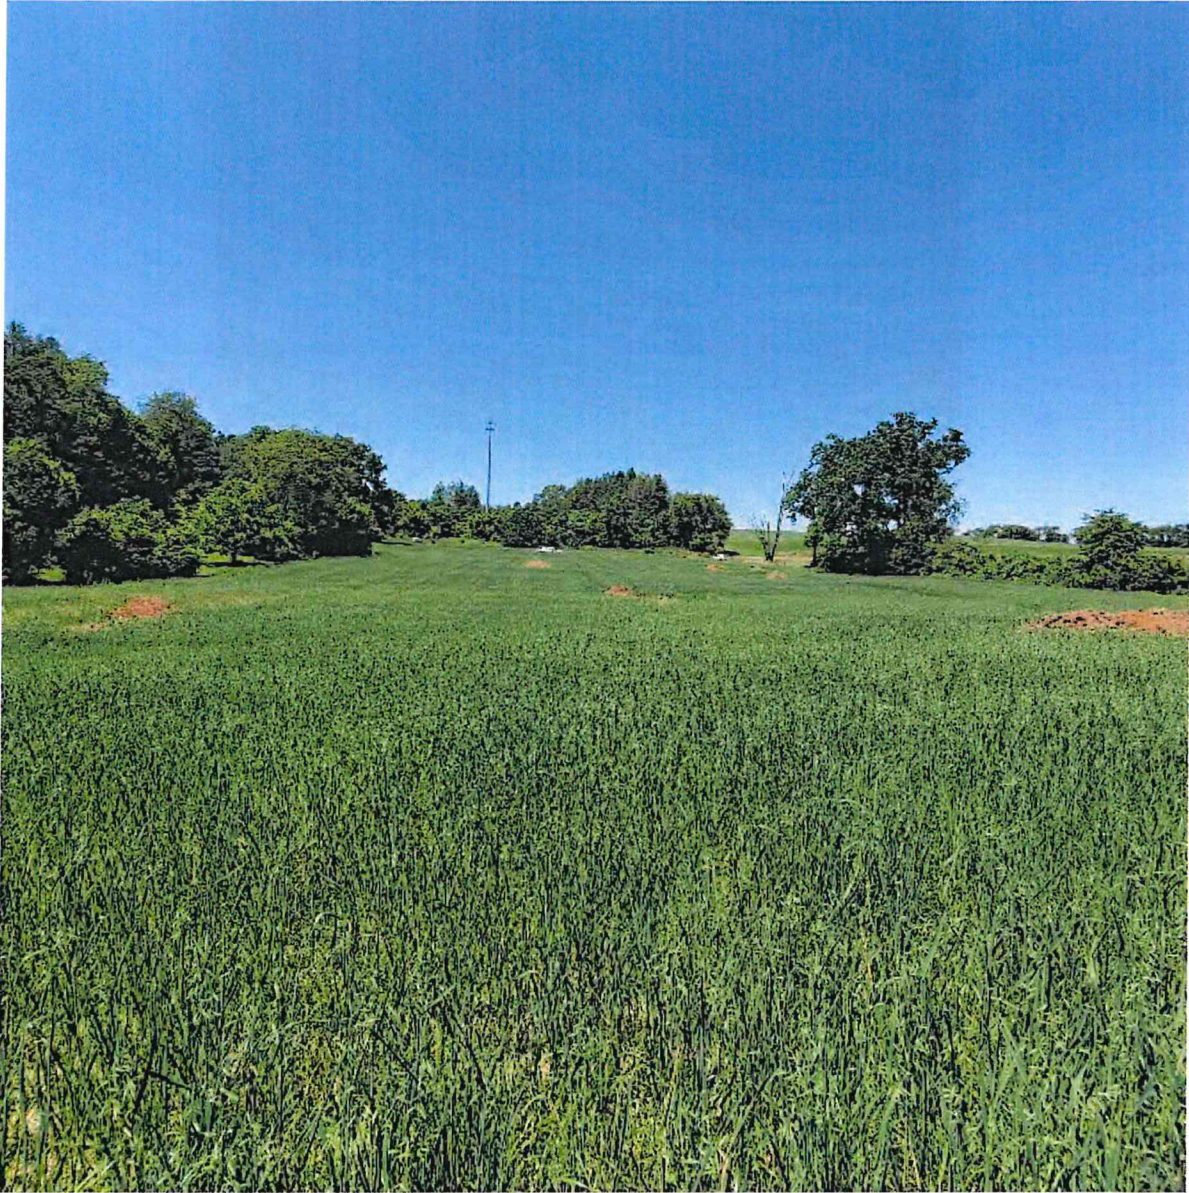
Photograph 2: Looking north across Areas A and B

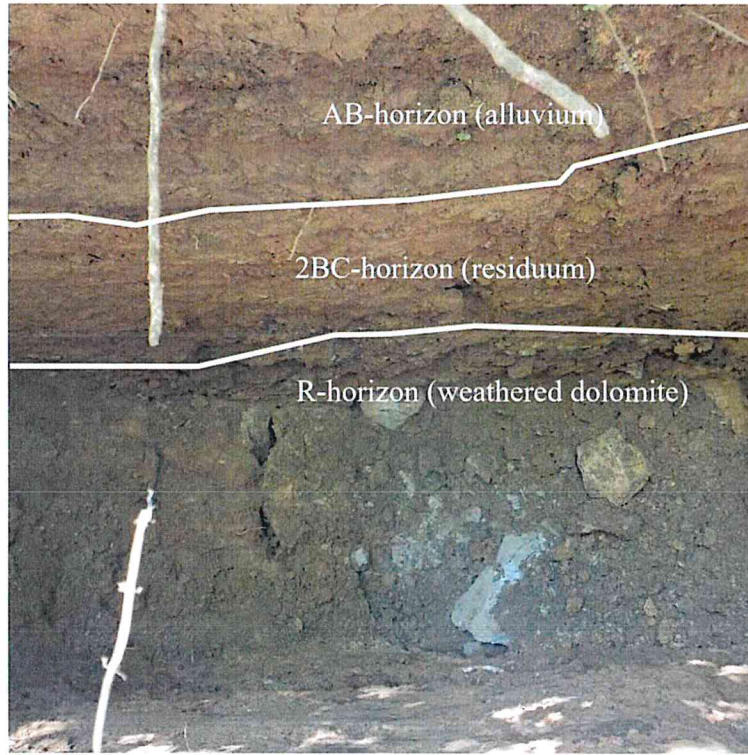
Photograph 3: Distinct boundaries between alluvium, residuum, and weathered rock (A4)

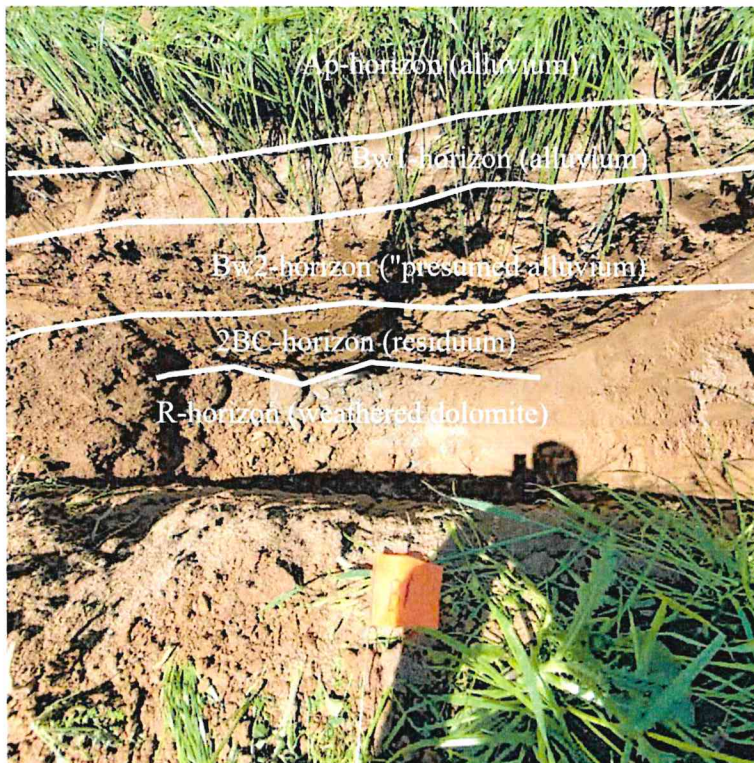
Photograph 4: Non-distinct boundaries between alluvium, residuum, and weathered rock (B1)

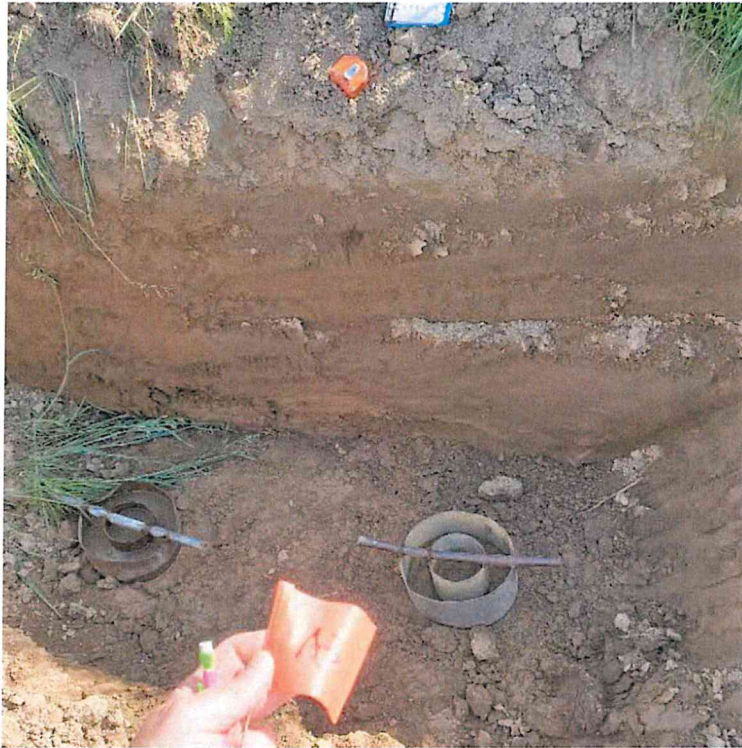
Photograph 5: Infiltrometer testing of alluvial AB-horizon at test pit A3

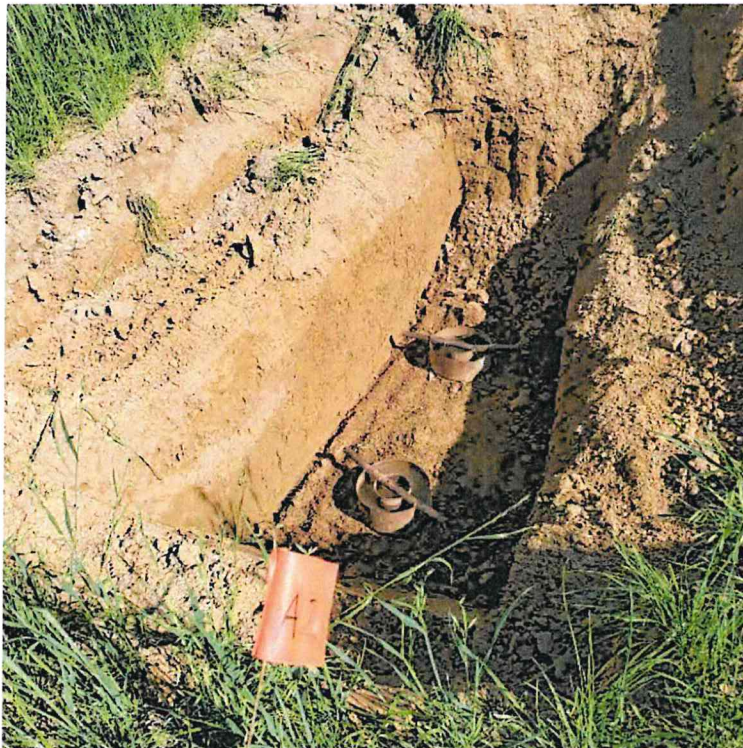
Photograph 6: Infiltrometer testing of "presumed" alluvial Bw<sub>3</sub>-horizon at test pit A2

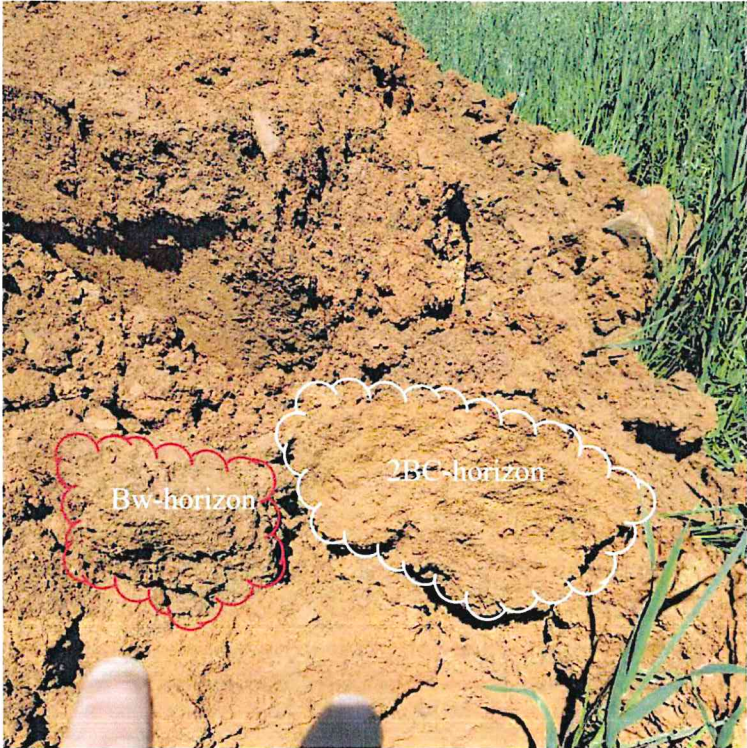
Photograph 7: Subtle difference between alluvial Bw-horizon and residual BC-horizon (A2)

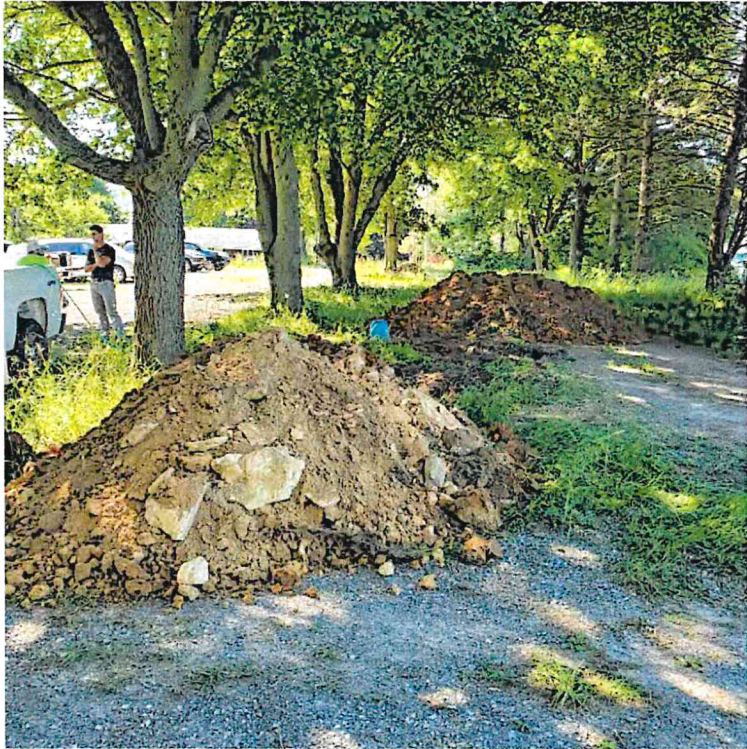
Photograph 8: Area C, looking south from test pit C1

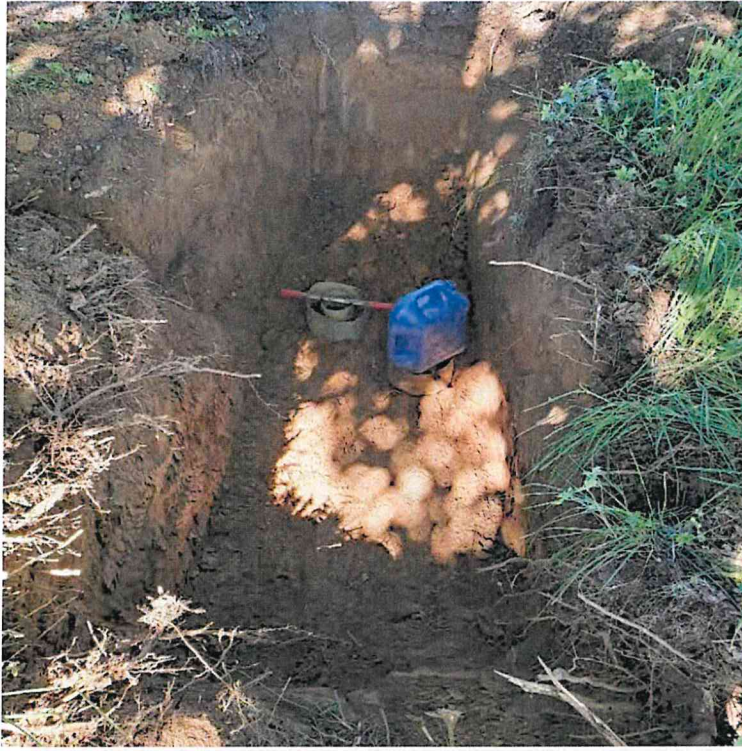
Photograph 9: Infiltrometer testing at test pit C1

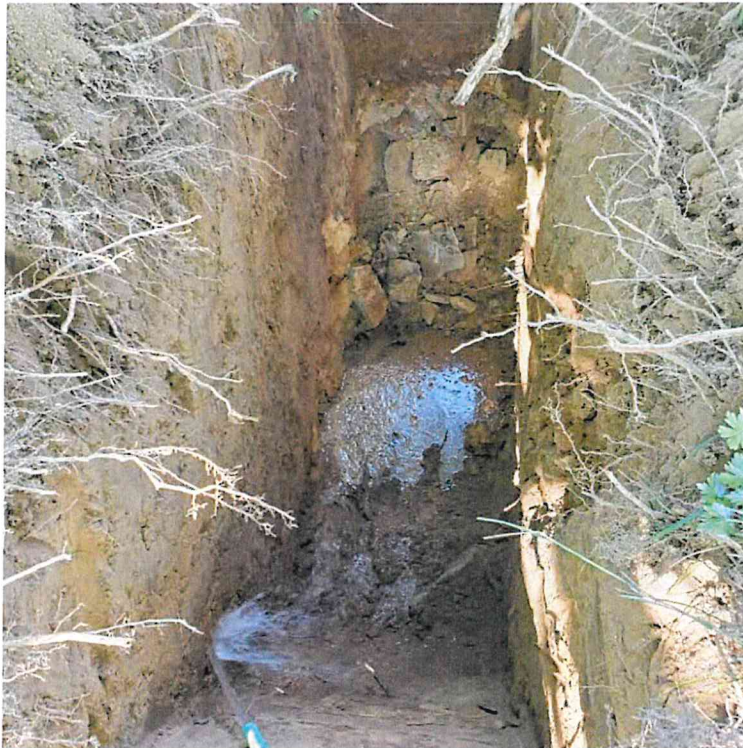
Photograph 10: Non-Conventional infiltration testing in test pit C1

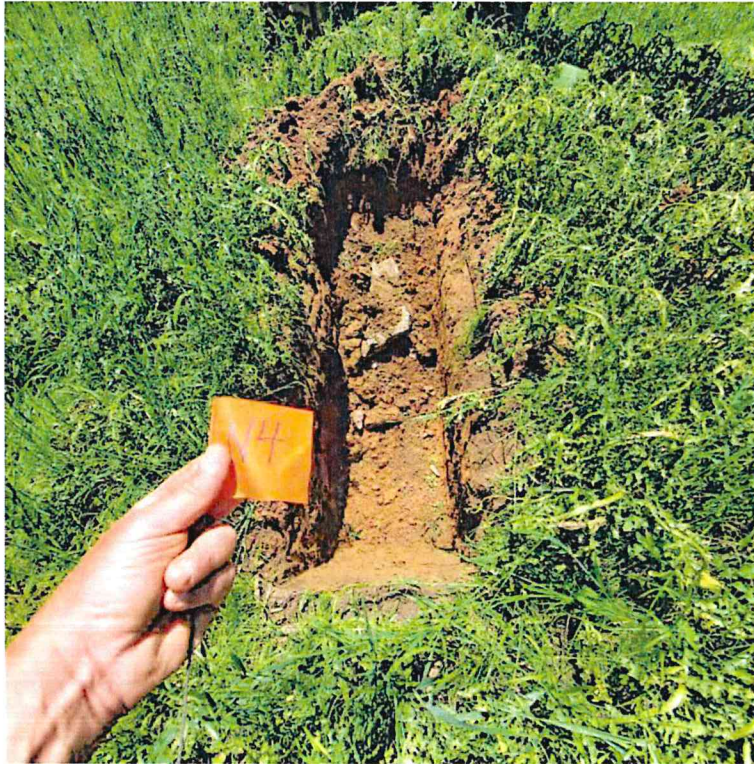
Photograph 11: Thin alluvium in test pit N4 (only 2' of "presumed" alluvium)

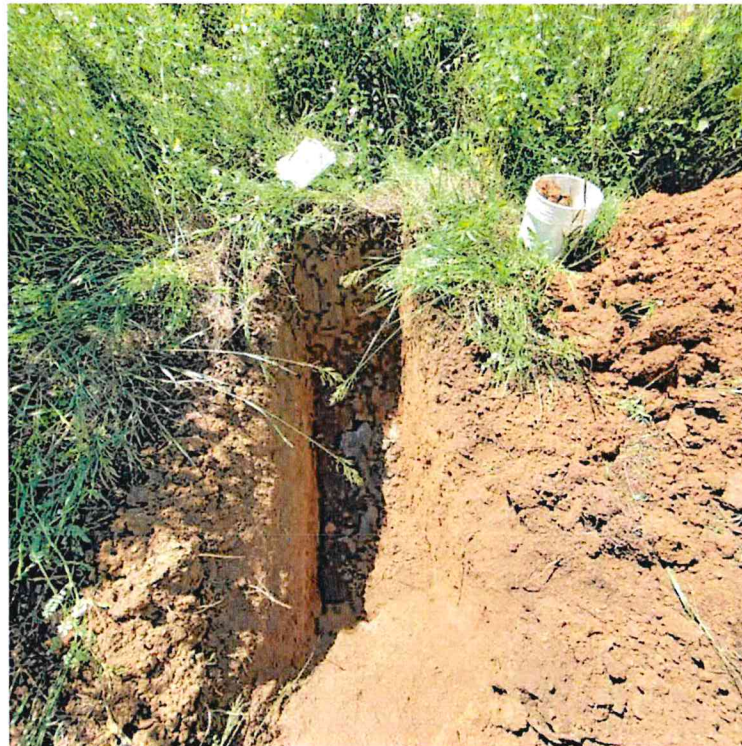
Photograph 12: Thin alluvium in test pit N1 (only 2' of "presumed" alluvium)
