FERGUSON TOWNSHIP BOARD OF SUPERVISORS

**Regular Meeting Agenda
Tuesday, November 15, 2022**

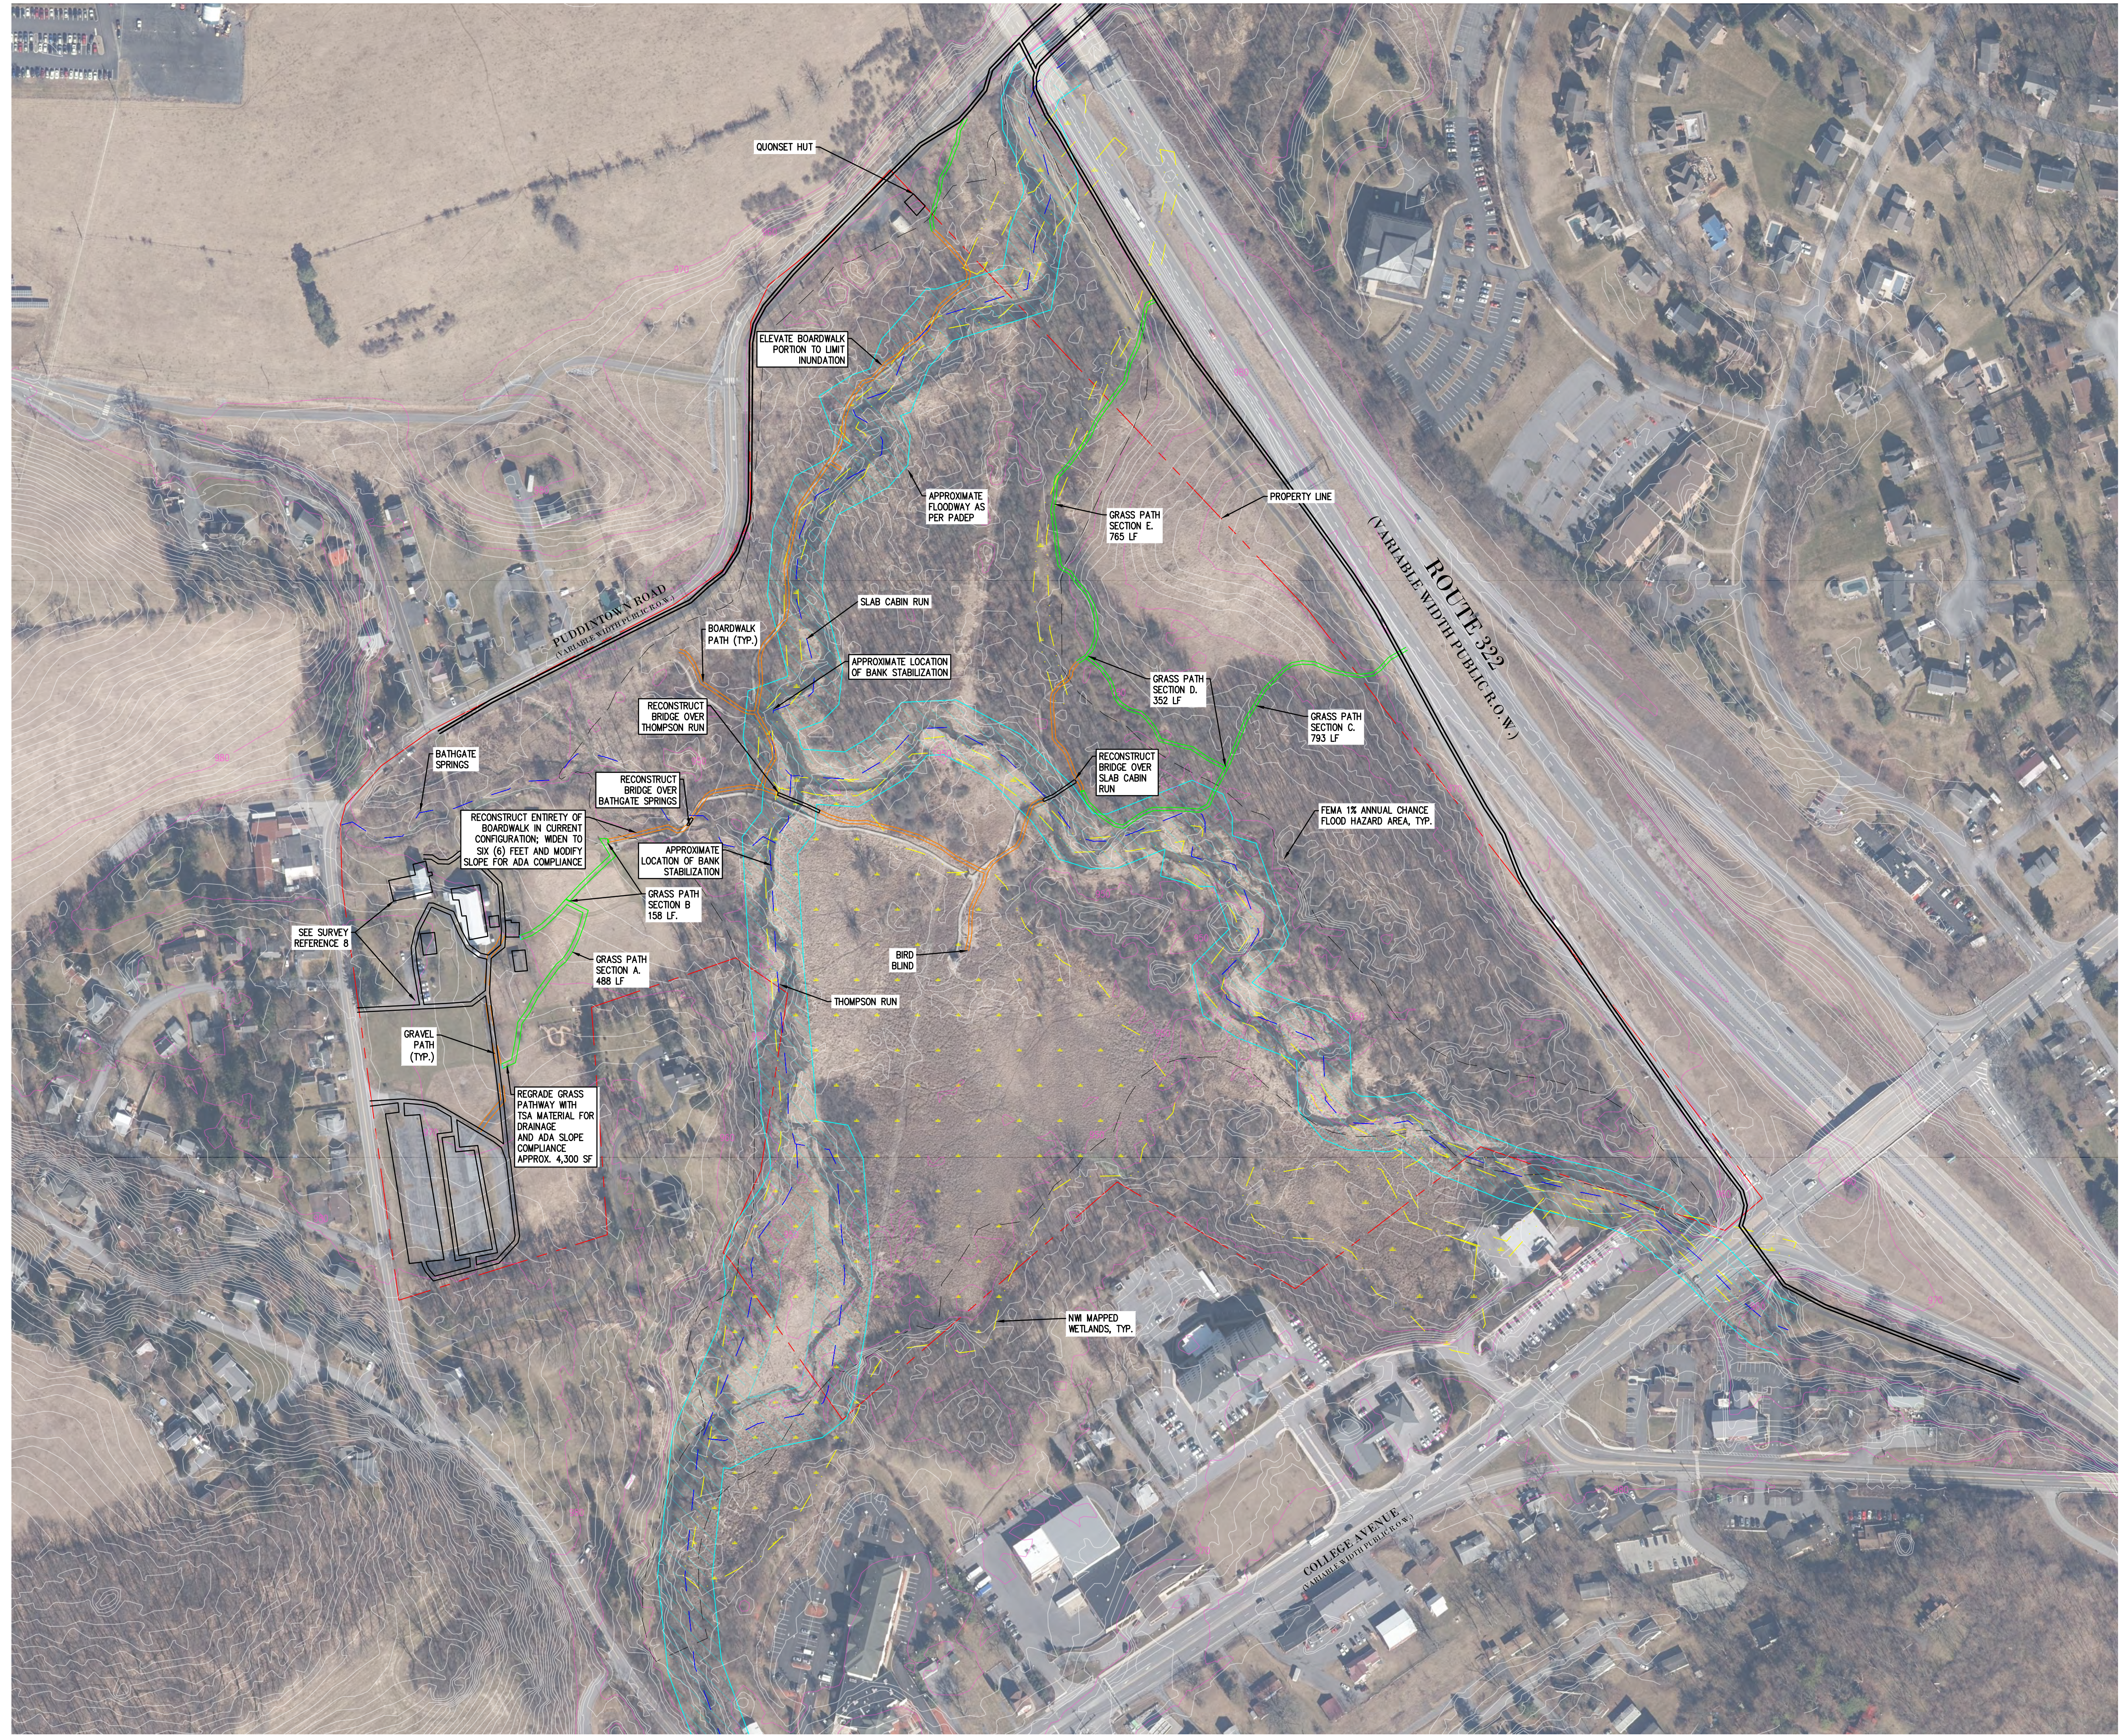
OPTION 1 DESCRIPTION

LEGEND	
PROPERTY LINE (PO)	--- (Red dashed)
MINOR CONTOUR (2')	--- (Black dashed)
MAJOR CONTOUR (10')	--- (Pink dashed)
BOARDWALK PATH	--- (Orange dashed)
GRASS PATH	--- (Green dashed)
GRAVEL PATH	--- (Blue dashed)
FEMA FLOOD HAZARD LINE	--- (Cyan dashed)
STREAM OR BROOK	--- (Blue solid)
FLOODWAY LINE AS PER PADEP	--- (Light blue solid)
FLOODWAY AREA	▨ (Light blue hatched)
NW WETLANDS BOUNDARY	--- (Yellow dashed)
WETLANDS	▨ (Yellow hatched)

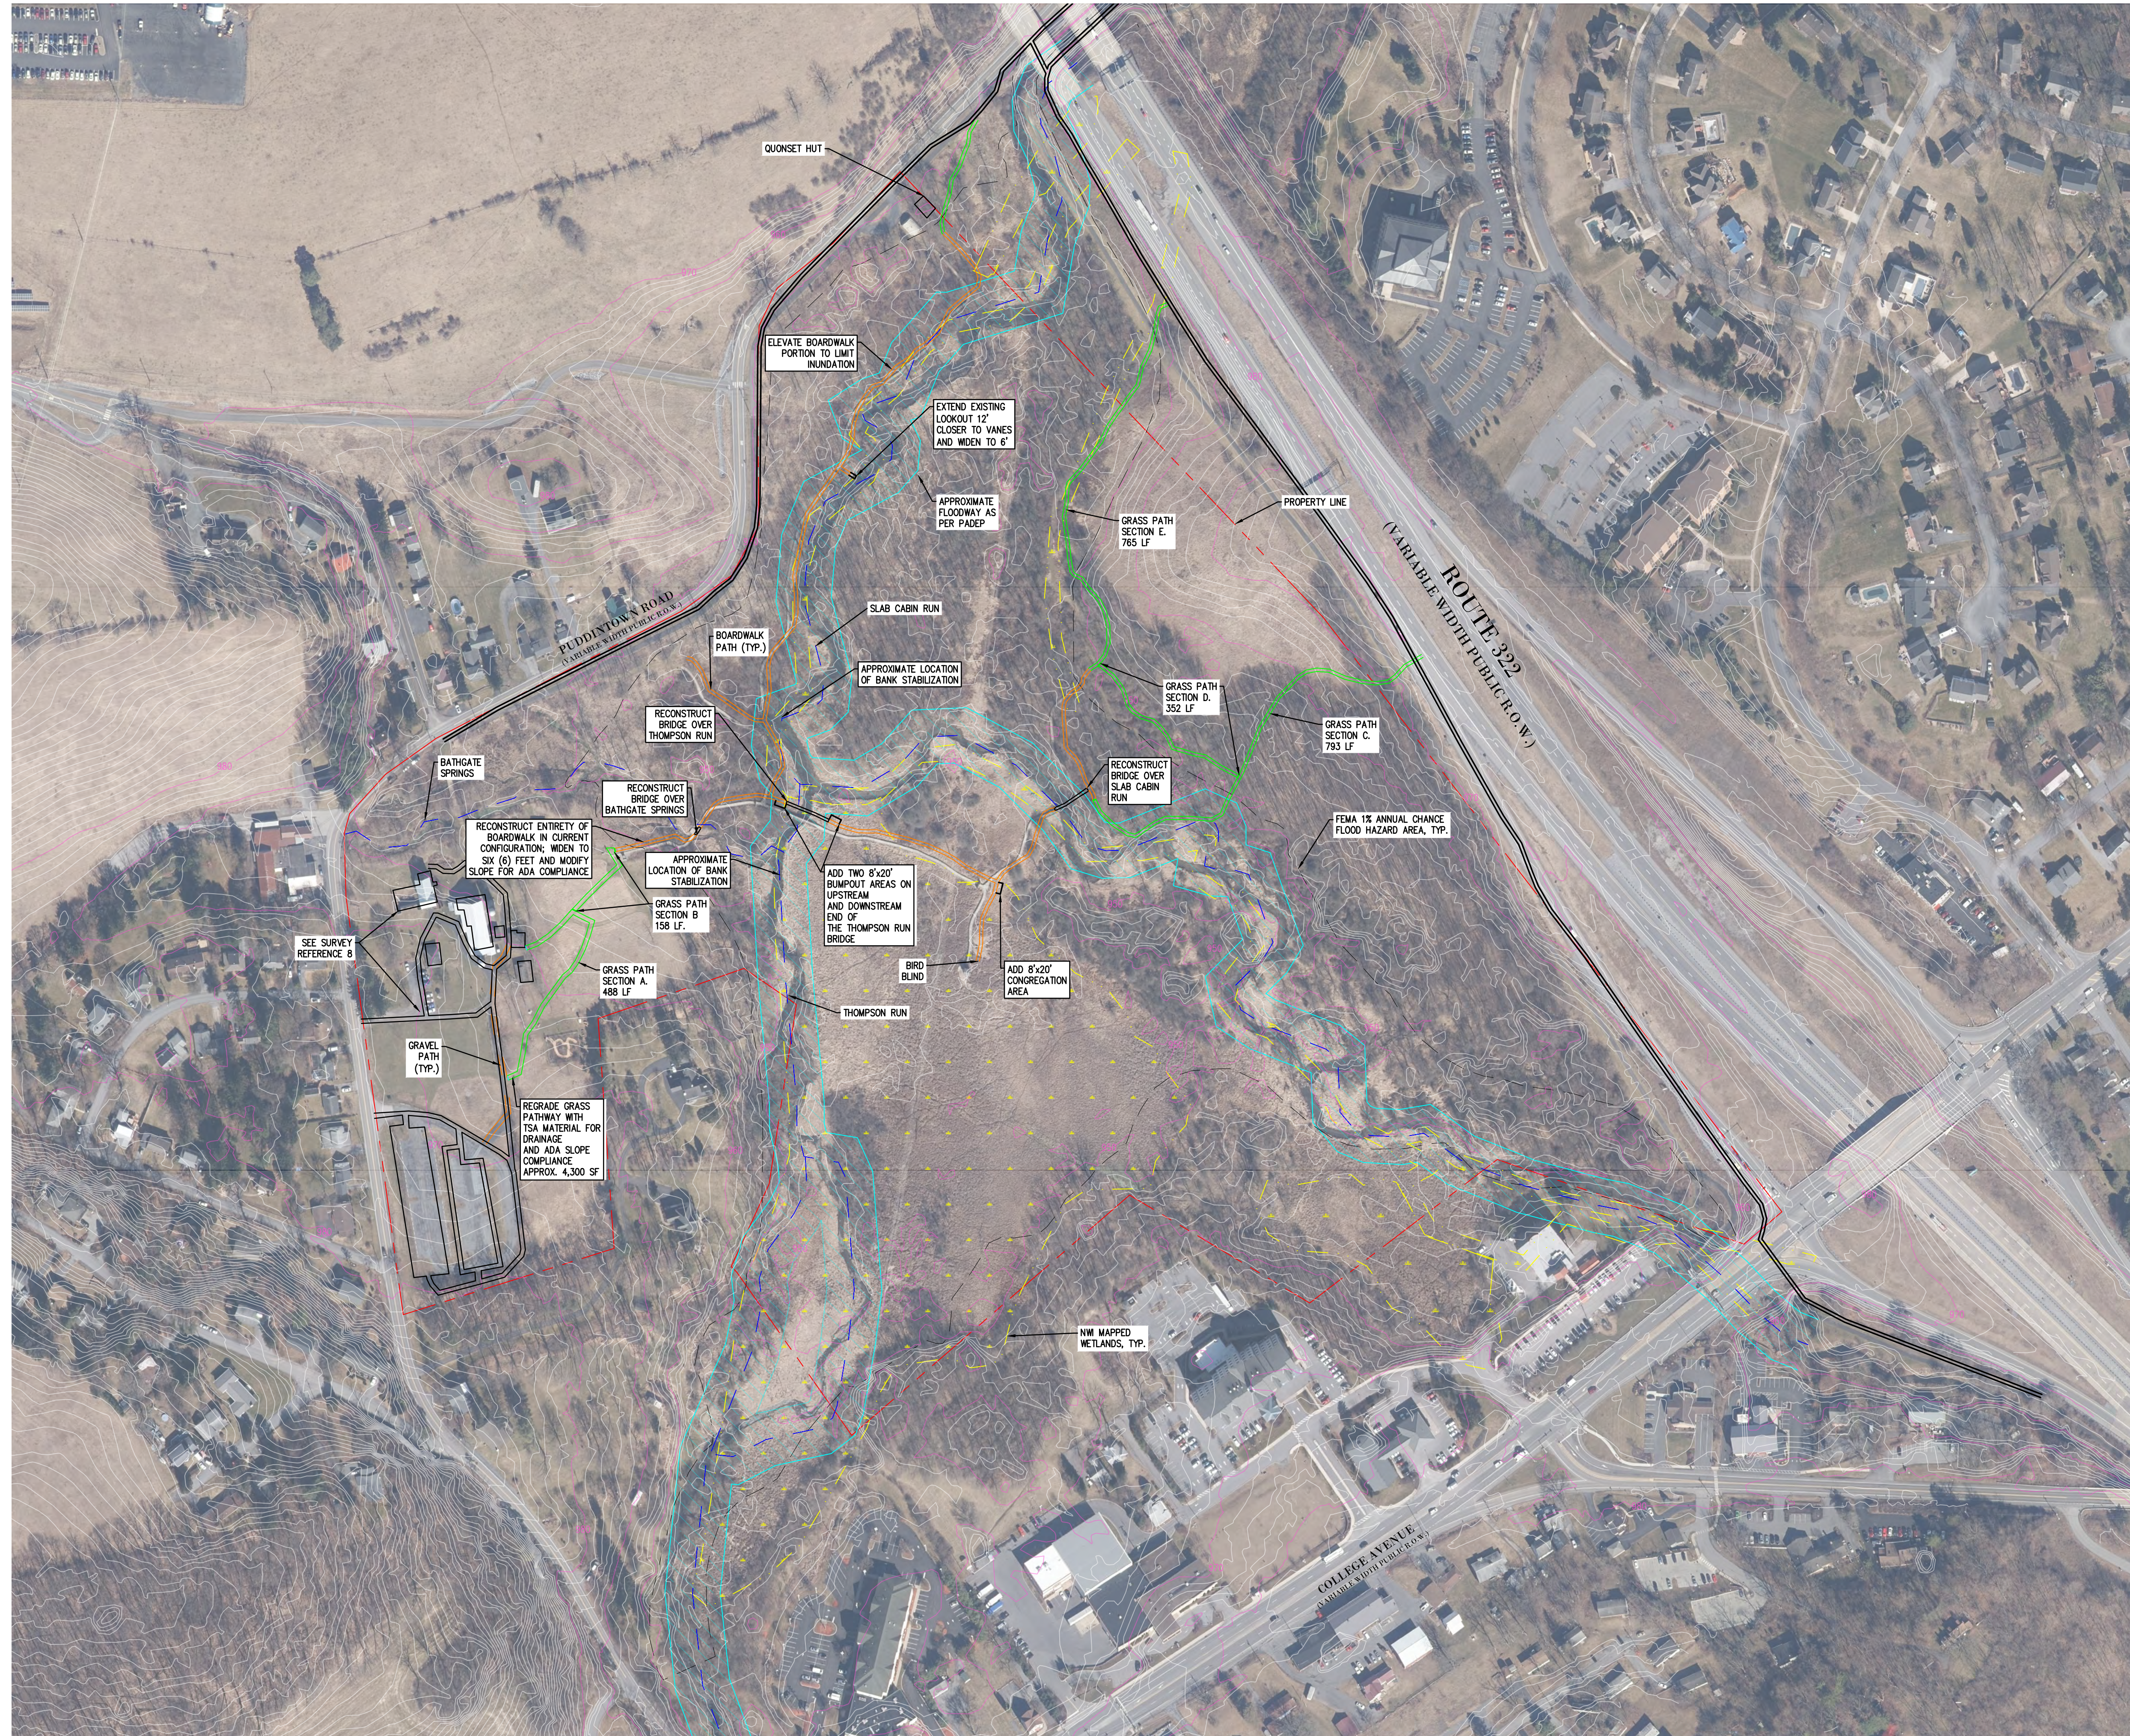
OPTION 2 DESCRIPTION

LEGEND	
PROPERTY LINE (PO)	---
MINOR CONTOUR (2')	---
MAJOR CONTOUR (10')	---
BOARDWALK PATH	---
GRASS PATH	---
GRAVEL PATH	---
FEMA FLOOD HAZARD LINE	---
STREAM OR BROOK	---
FLOODWAY LINE AS PER PADEP	---
FLOODWAY AREA	---
NW WETLANDS BOUNDARY	---
WETLANDS	---

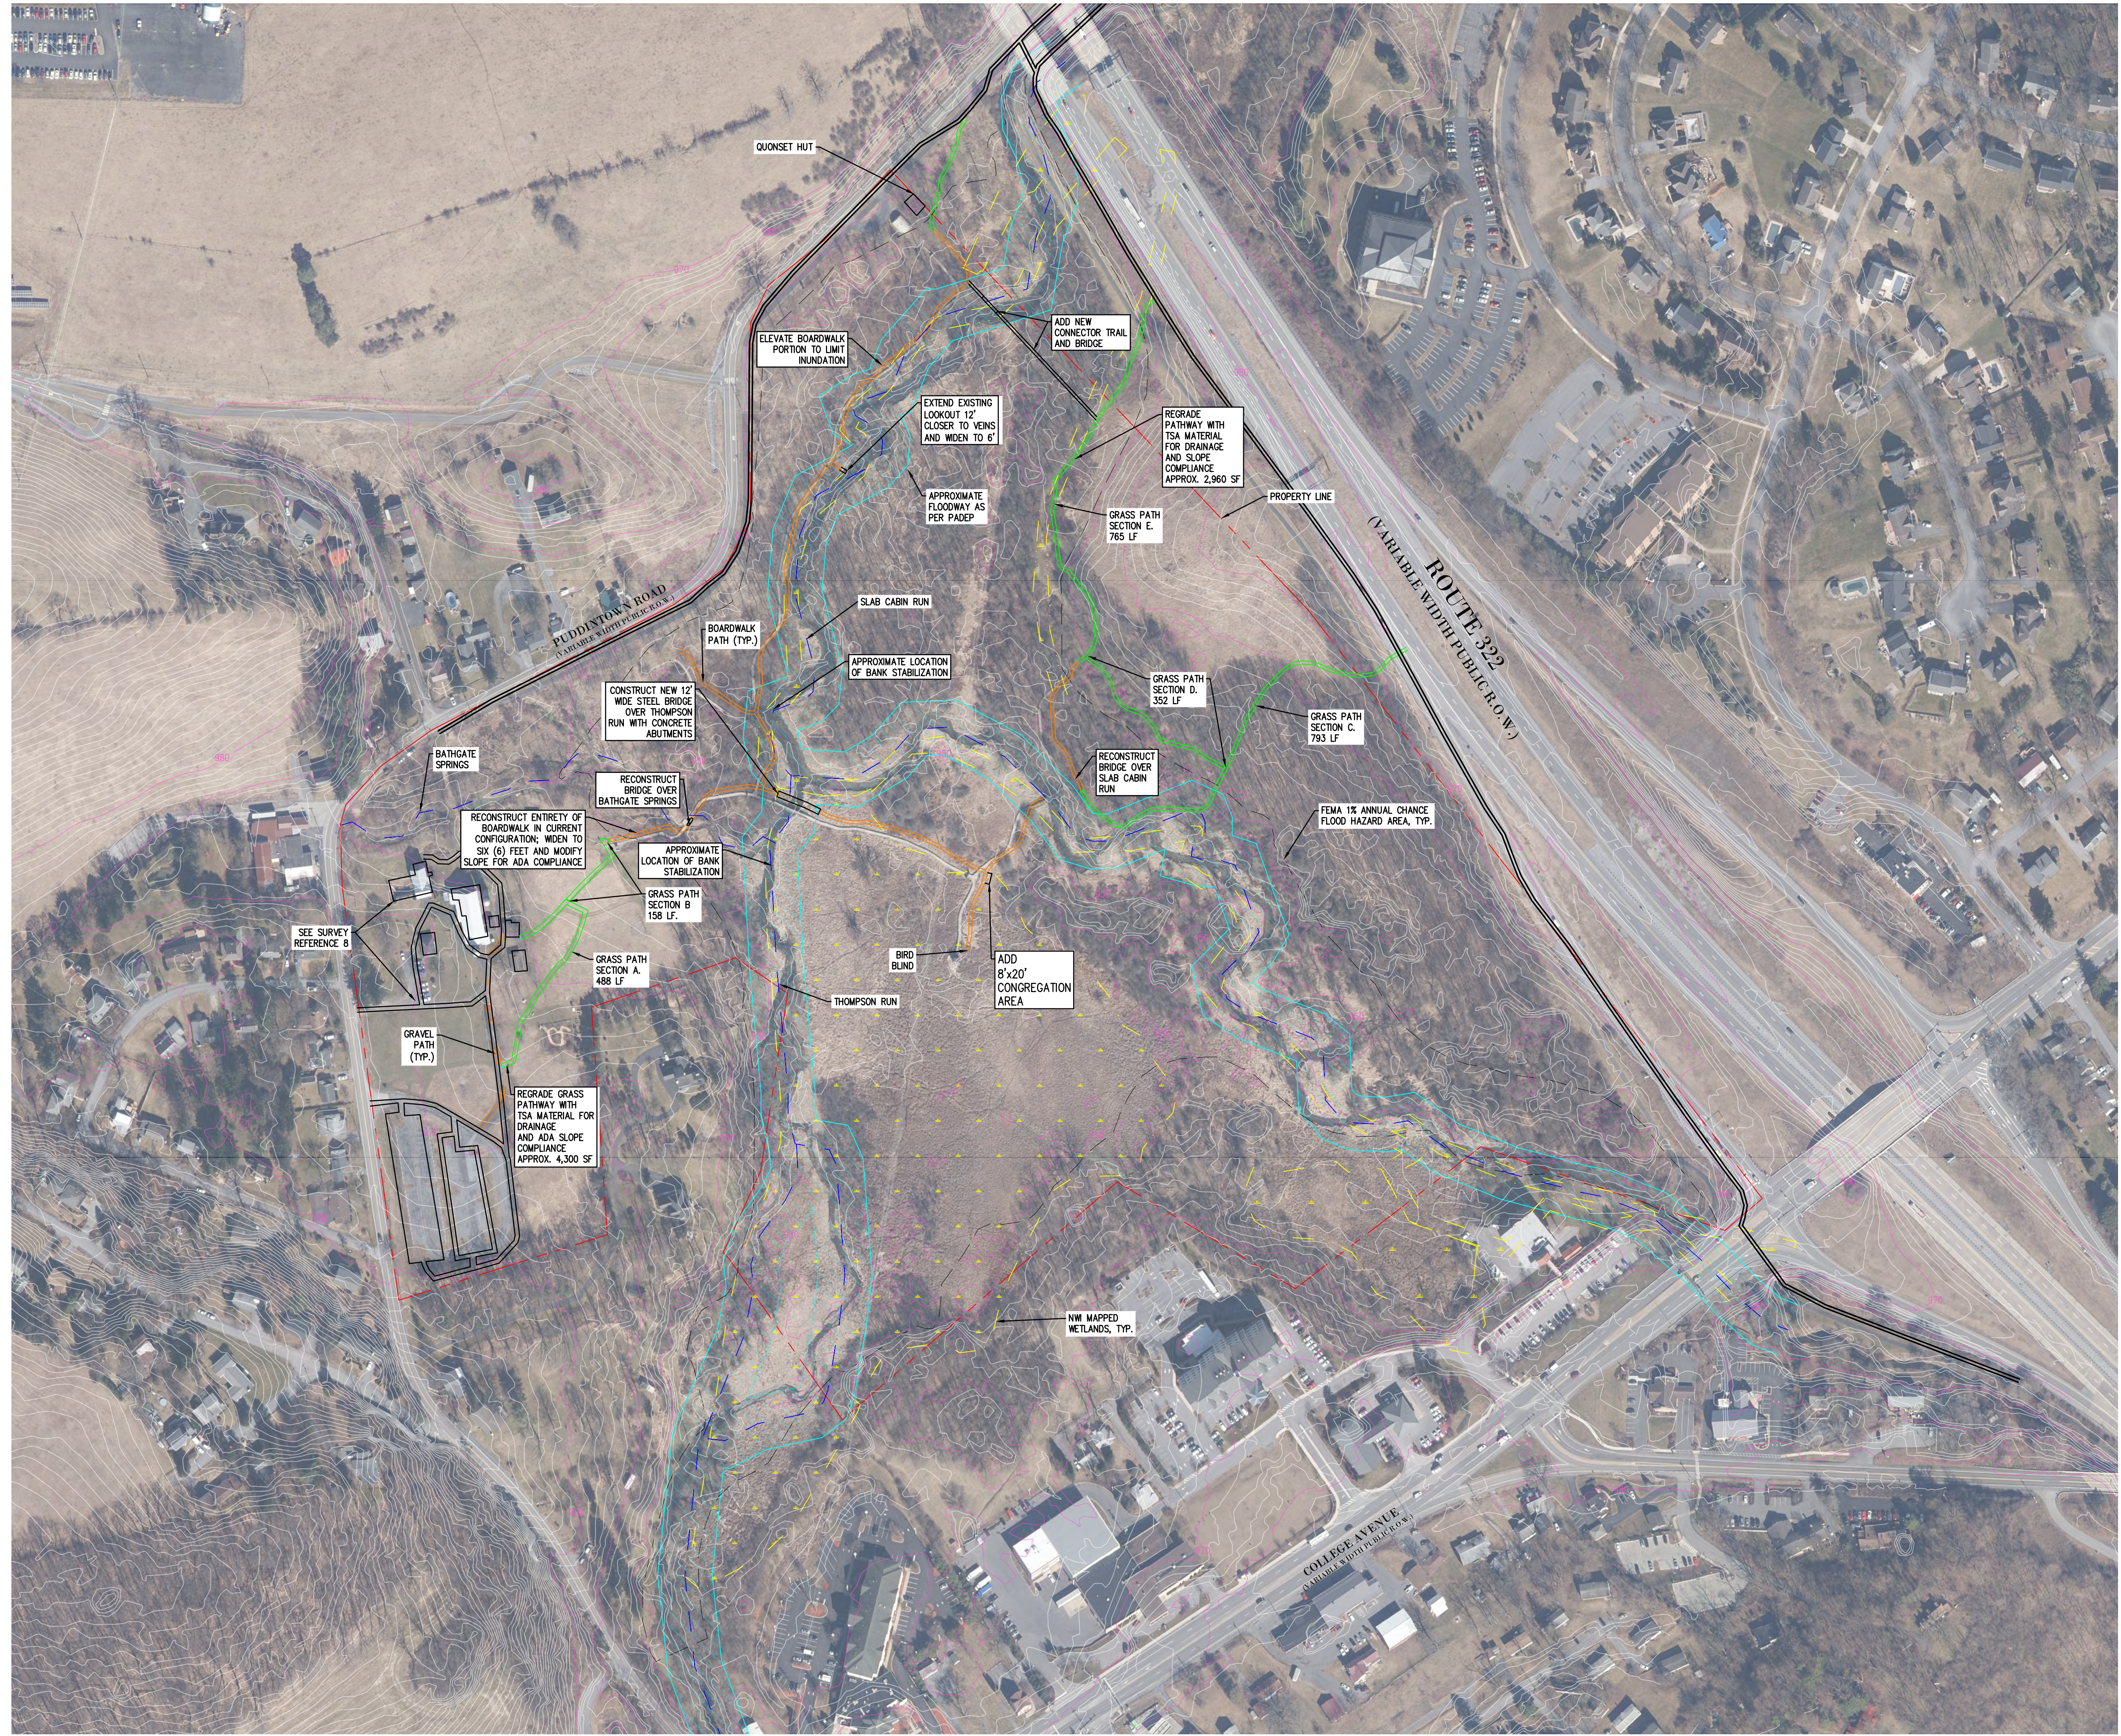
OPTION 4 DESCRIPTION

LEGEND	
PROPERTY LINE (PO)	--- (Red dashed)
MINOR CONTOUR (2')	--- (Pink dashed)
MAJOR CONTOUR (10')	--- (Green dashed)
BOARDWALK PATH	--- (Blue dashed)
GRASS PATH	--- (Yellow dashed)
GRAVEL PATH	--- (Orange dashed)
FEMA FLOOD HAZARD LINE	--- (Black dashed)
STREAM OR BROOK	--- (Blue solid)
FLOODWAY LINE AS PER PADEP	--- (Cyan solid)
FLOODWAY AREA	--- (Blue hatched)
NW WETLANDS BOUNDARY	--- (Yellow dashed)
WETLANDS	--- (Yellow solid)

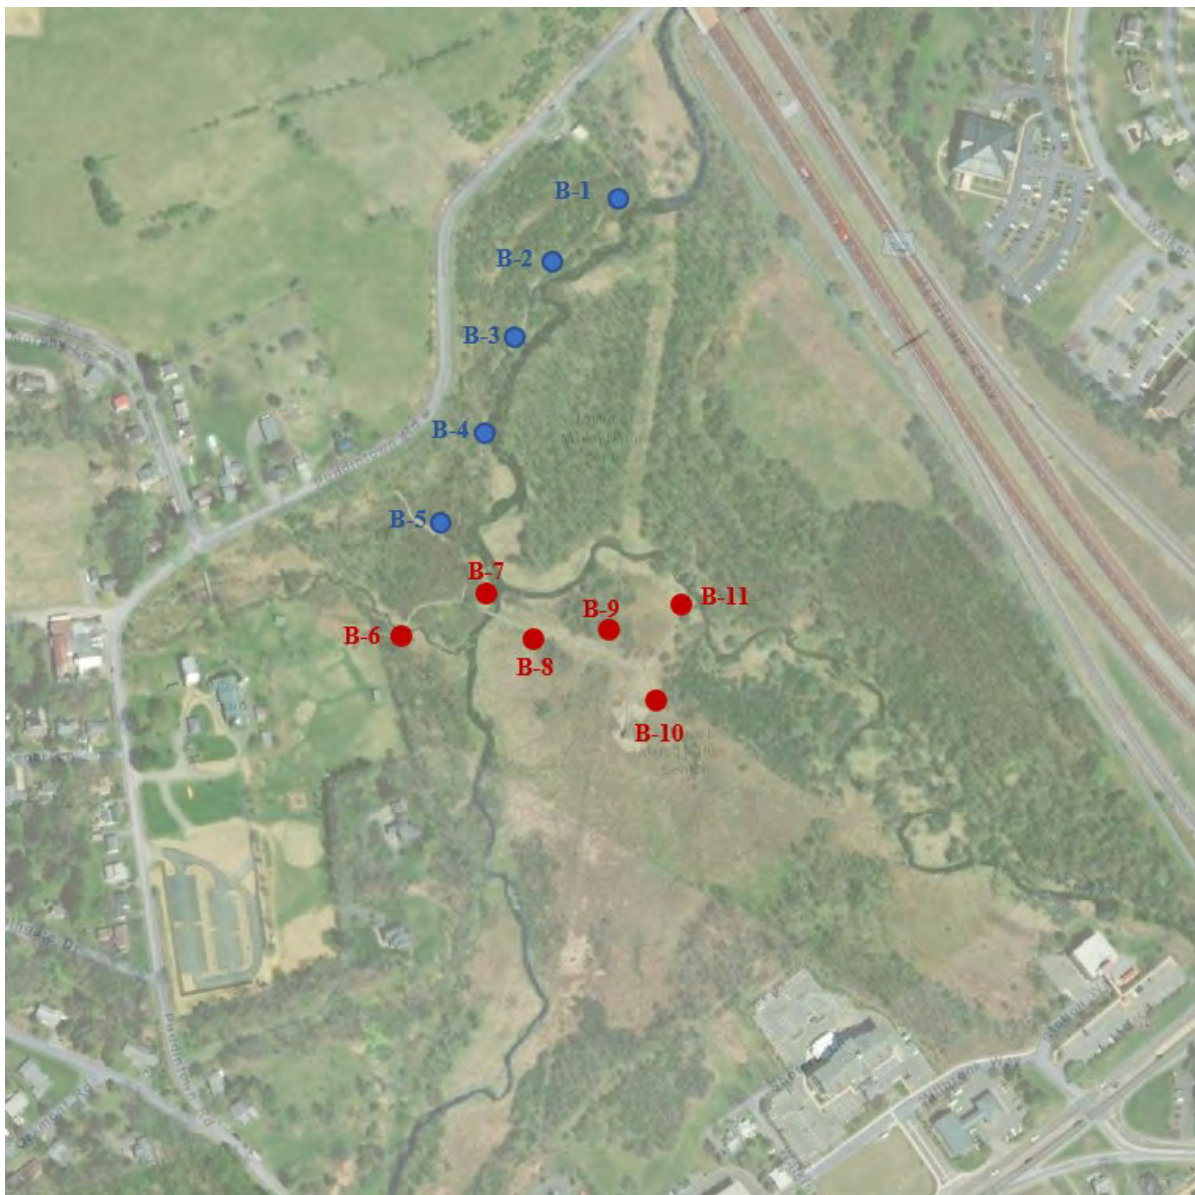
In order to confirm relative uniformity of soil conditions throughout the site, LAN consulted CMT Labs to conduct eleven (11) soil borings at various locations. Boring locations B-1 through B-5 were drilled with a conventional drilling rig and were extended to depths ranging between 11 and 15 feet below grade. Boring locations B-6 through B-11 were drilled with hand sampling techniques and were extended to depths ranging between 4 and 7 feet below grade. Groundwater was encountered within the test boring locations at the time of the field operations at approximate depths ranging between 0.5 and 9.5 feet below grade.

Based on the findings, it is recommended that helical piles are considered appropriate foundations for the boardwalk replacement project. The full report by CMT Laboratories is included herein as “Appendix C”.

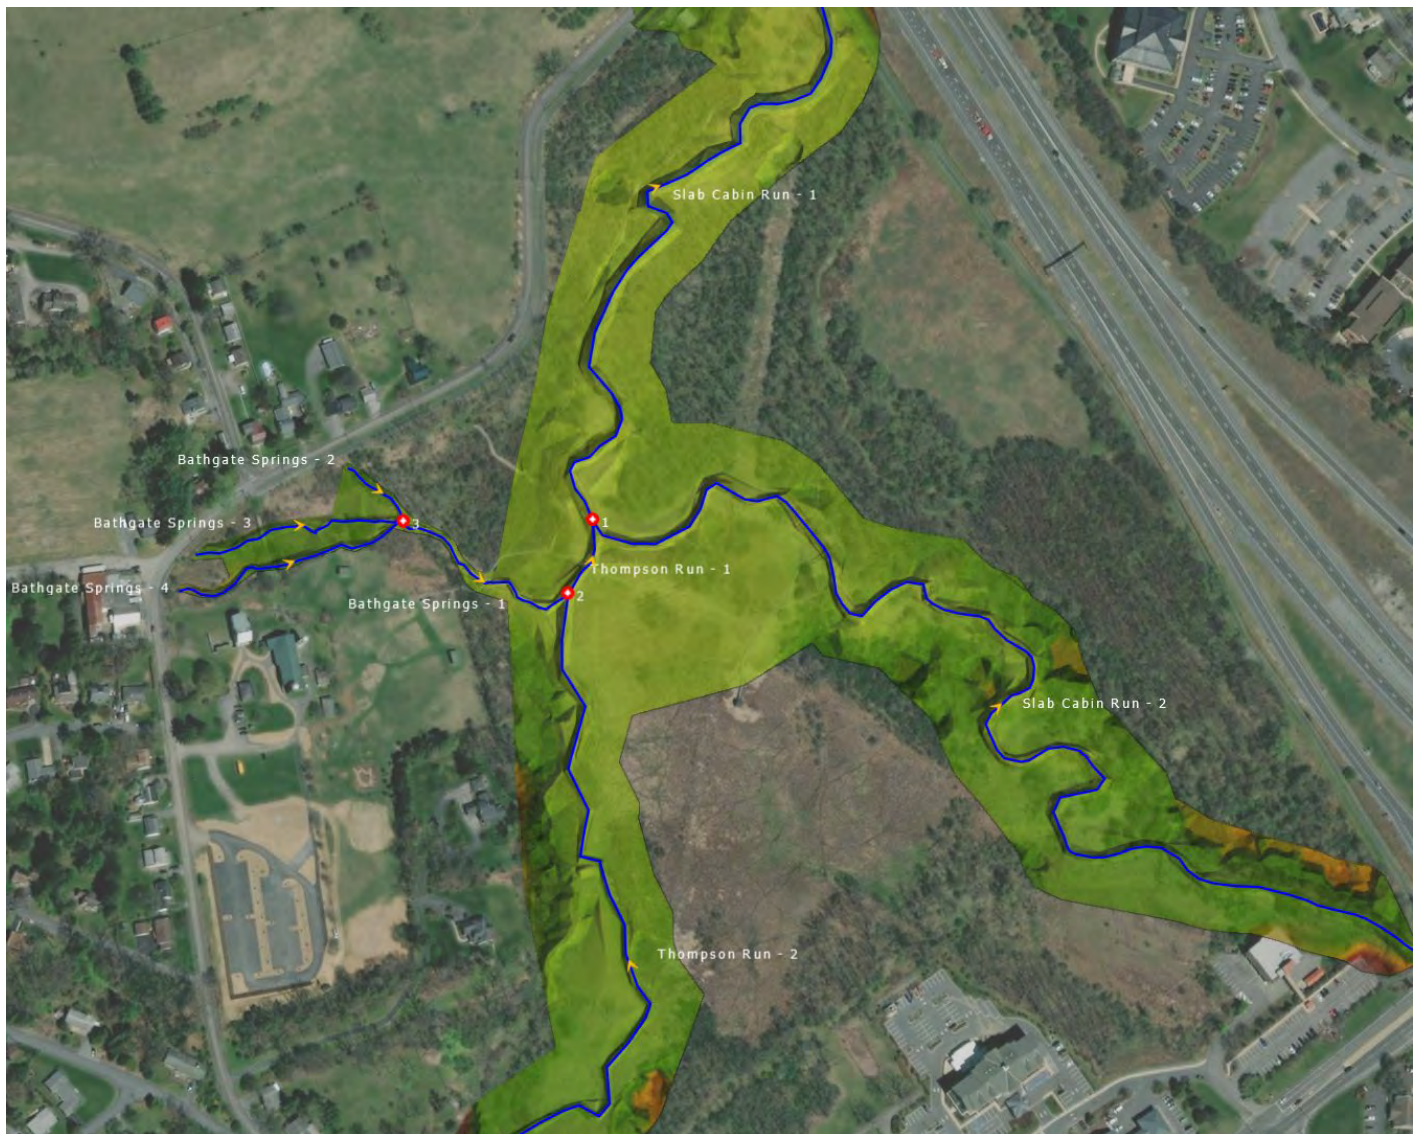
Cross sectional data of Slab Cabin Run, Thompson Run, and their various reaches was obtained via survey investigation and was entered into CivilGEO© Engineering Software 2022 GeoHECRAS software. A terrain model was created based on topographic survey data and stream reaches and junctions were arranged accordingly.

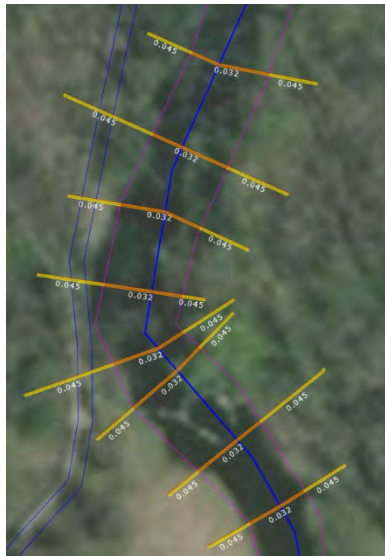
Cross sections were laid out perpendicular to the banks and flow lines for each reach of each river. The existing bridges and the proposed bridge on the connector loop trail were modeled accordingly.

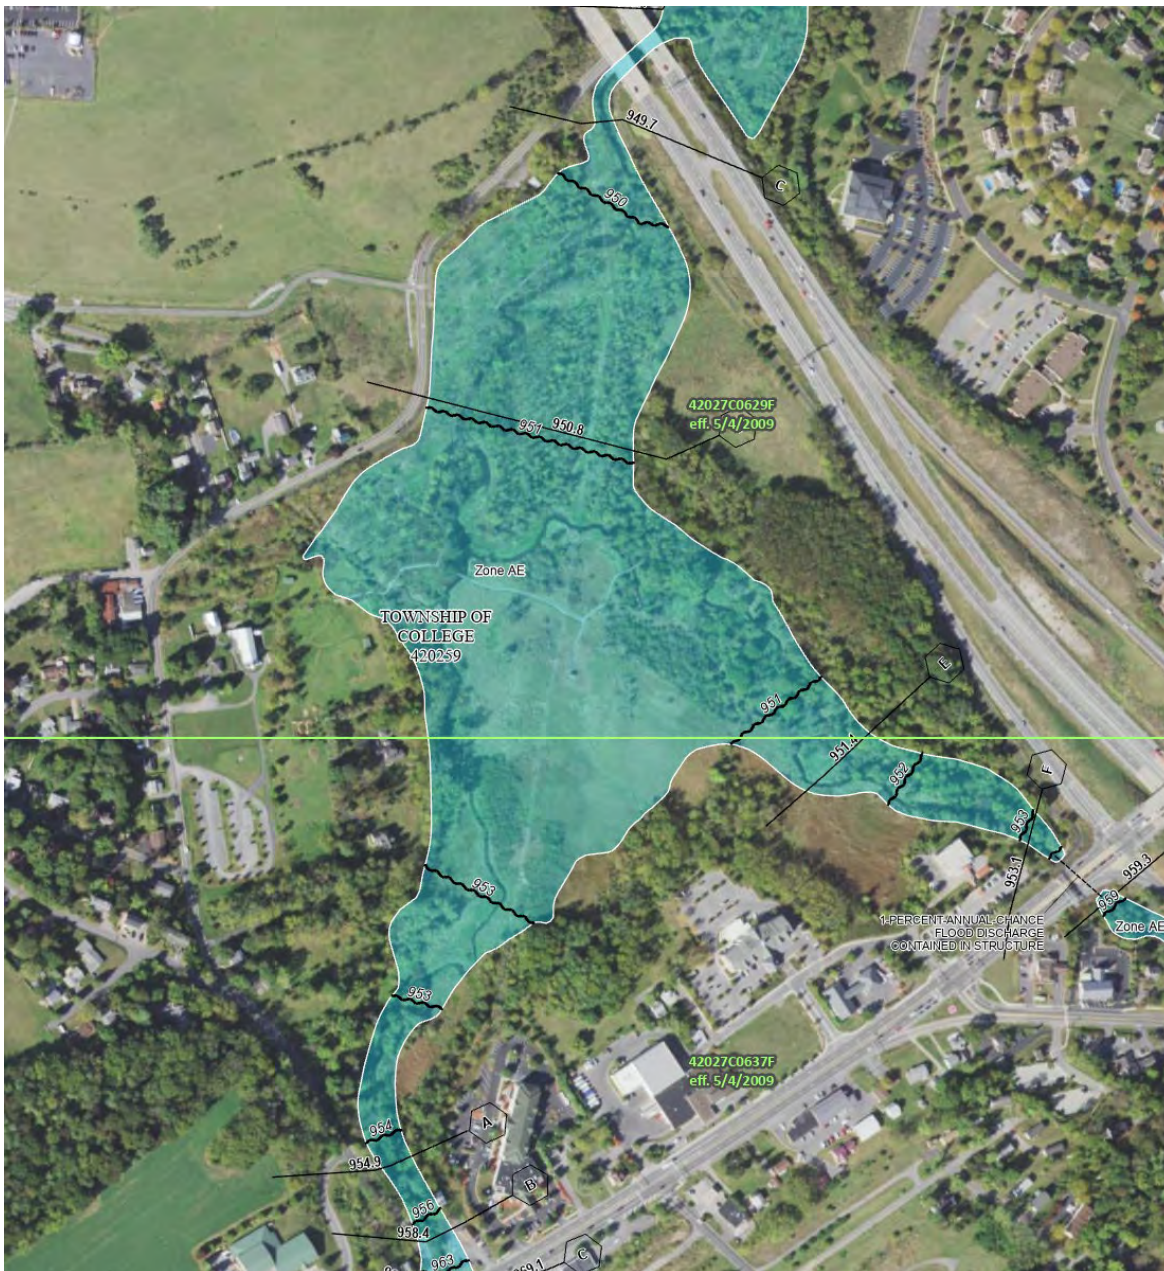
FEMA mapping shows the subject site on FIRM Panels 42027C0629F and 42027C0637F, having a base flood elevation ranging from 954 ft – 950 ft (NGVD29). Most of the site lies within the flood hazard area.

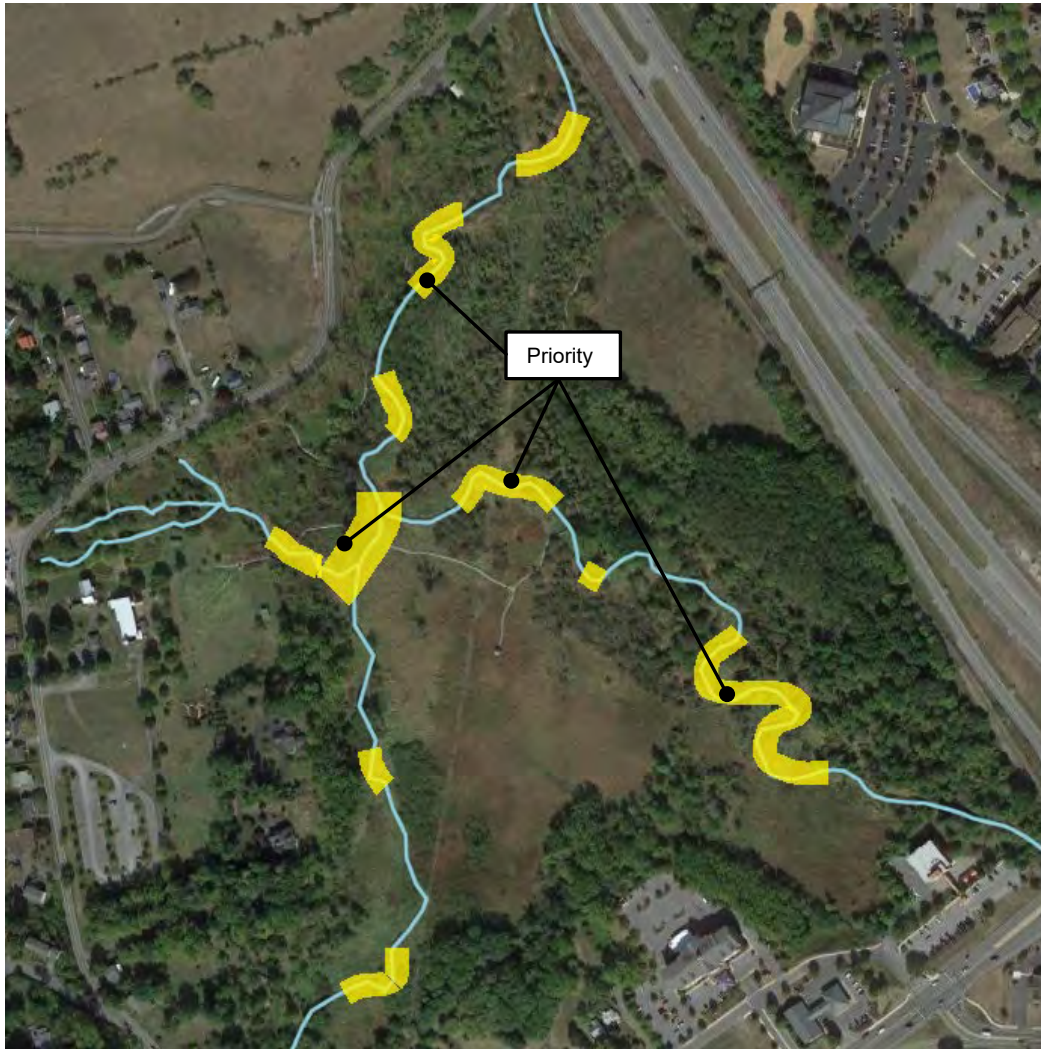
Based on the analysis detailed above and geometry, the areas subject to streambank stabilization are outlined as follows:

The areas deemed priorities are areas of high traffic, or areas identified by visual inspection. These areas will be the focus of the streambank stabilization.

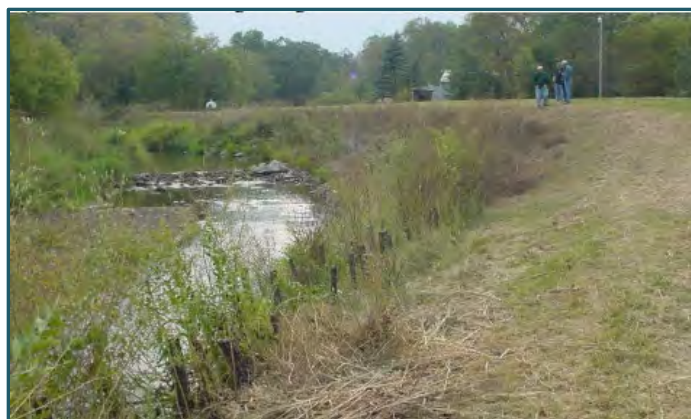
Live stakes growing on a streambank one season after installation.

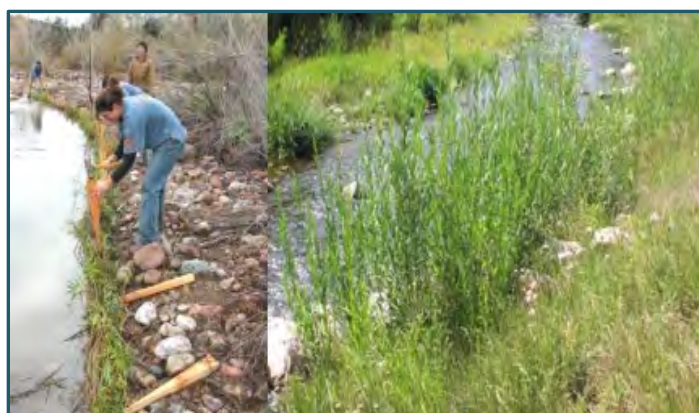
Live fascines during installation (left) and after establishment (right).

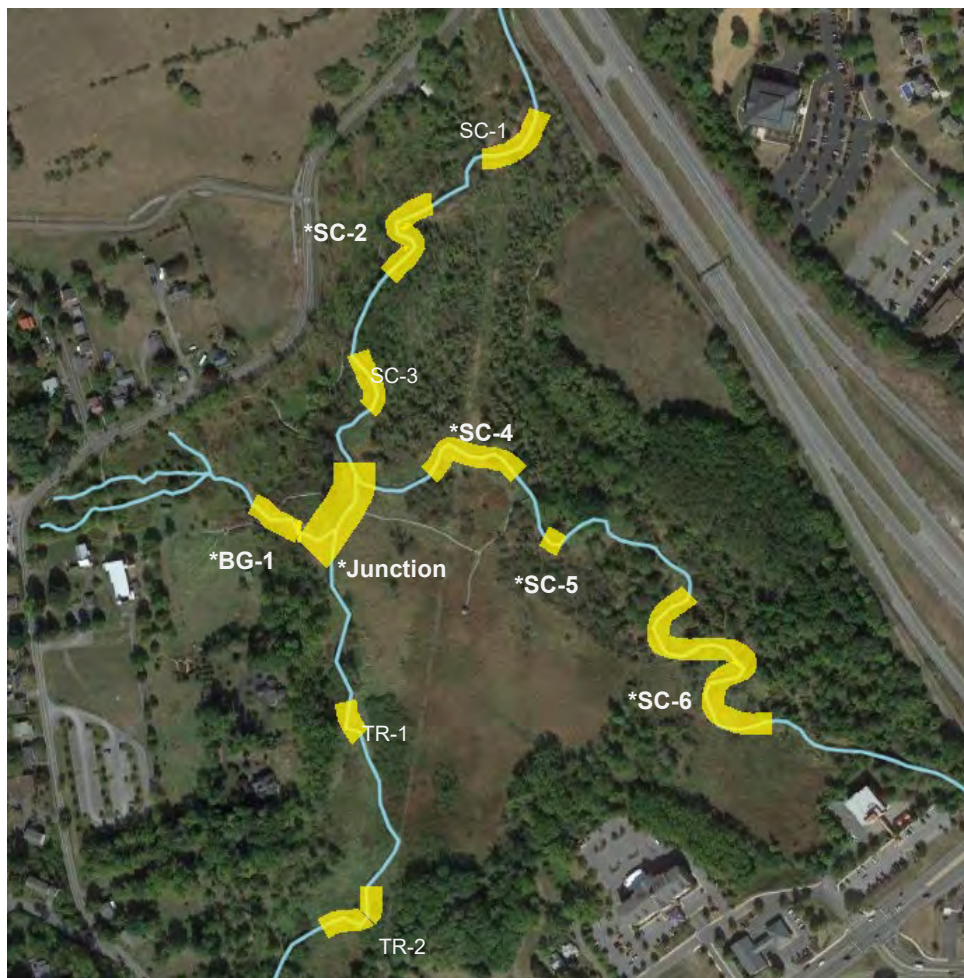
* Stakes are 1/2" – 1 1/2" diameter, spaced 3 feet apart.

~Cuttings for bundle are 1/4 "– 1" diameter. Bundle is 6" – 8" diameter and 5-10 feet long.

It is recommended that there be at least 2 rows of either live stakes, or live fascines in each area. Erosion control blanket sizes vary depending on the vendor. The following table summarizes the area of streambank stabilization per location, assuming 2 rows are used.

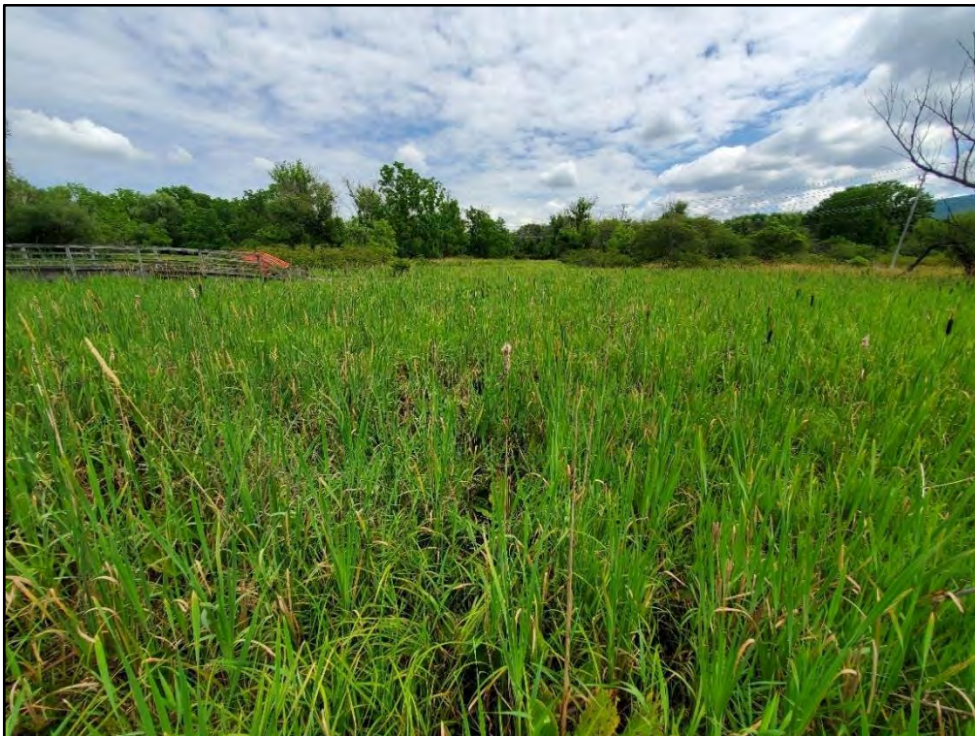
Photo 4 – View northeast, of the boardwalk bridge over Thompson Run to the left, surrounded by the *Carex utriculata* dominated sedge meadow.

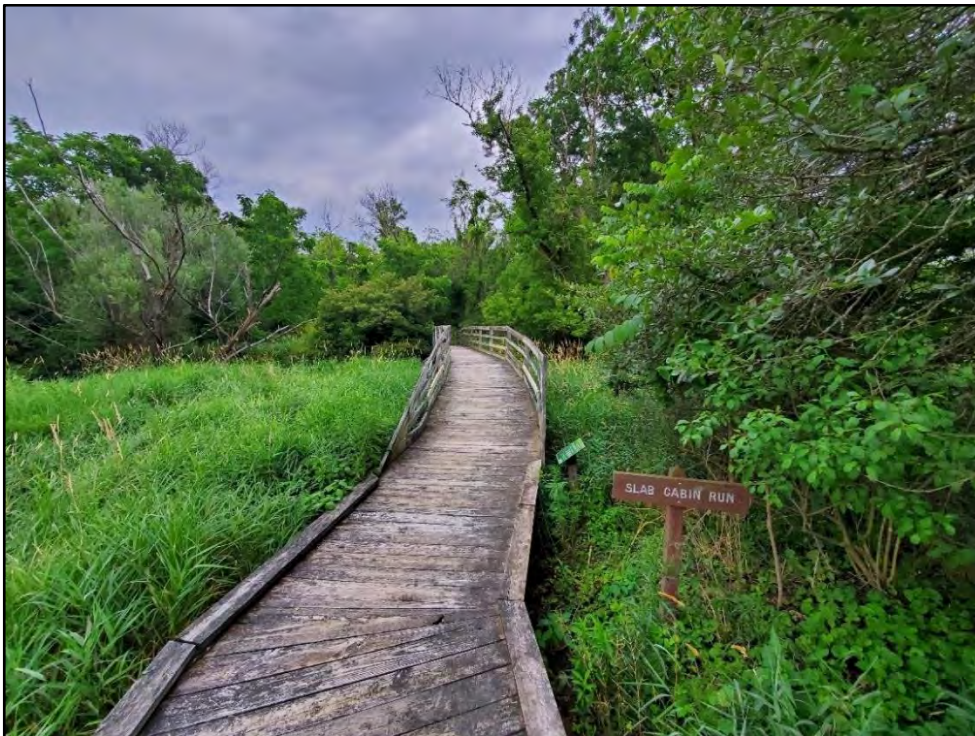
Photo 6 – View northeast of the existing boardwalk bridge over Slab Cabin Run. The sedge meadow to the west (left side of the photo) is dominated by *Carex trichocarpa*.

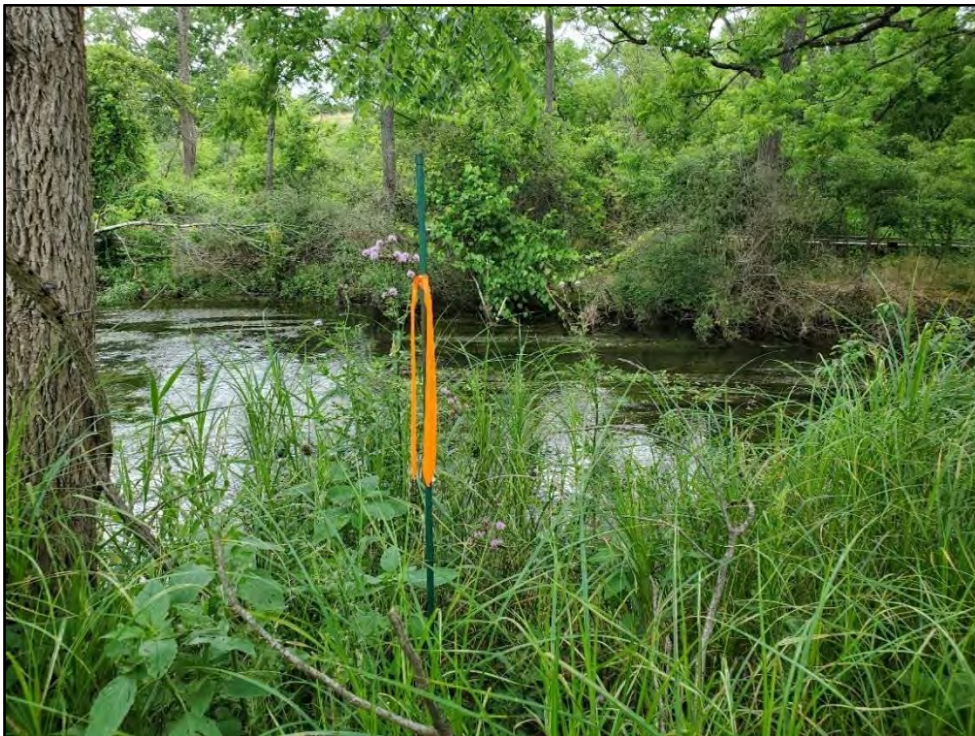
Photo 10 – View west of the proposed new bridge crossing over Slab Cabin Run, in the northern portion of the Survey Area. The existing boardwalk that the bridge will tie into is visible in the right background of the photo.

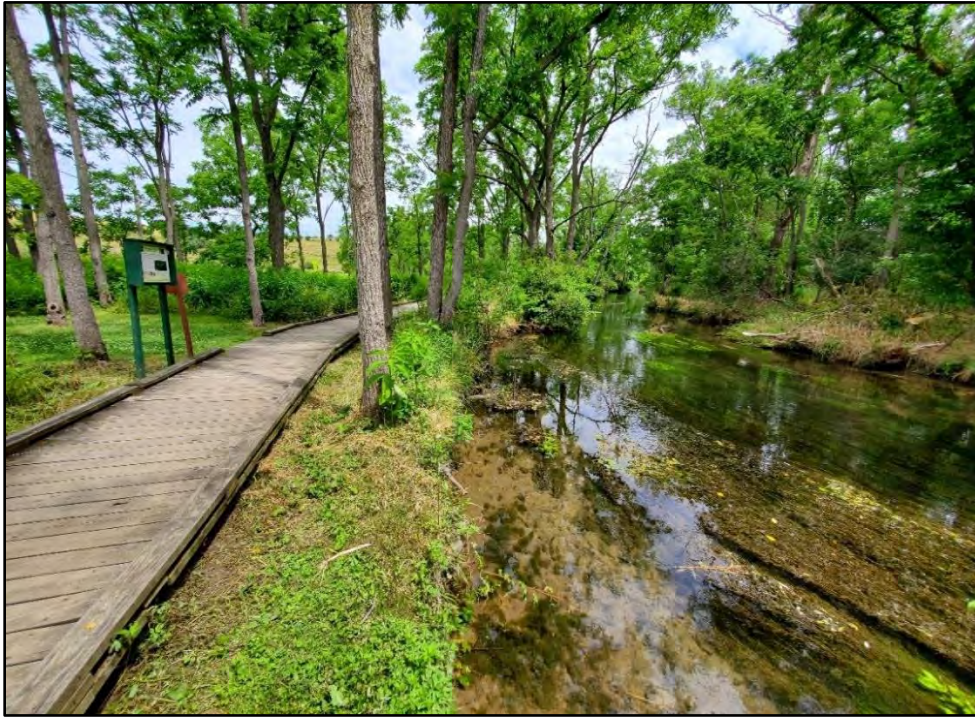
Photo 11 – View north of the existing boardwalk where it parallels Slab Cabin Run, on the northwest side of the Survey Area. *Potamogeton crispus* is observed growing in the river channel. The riparian vegetation has been recently mowed.
